In-Situ Monitoring and Testing of IBRC Bridges in Wisconsin

In-Situ Monitoring and Testing of IBRC Bridges in Wisconsin (WHRP 10-09). Milwaukee, Wisconsin, Marquette University, Department of Civil, Construction, and Environmental Engineering (2010).

WHRP 10-09

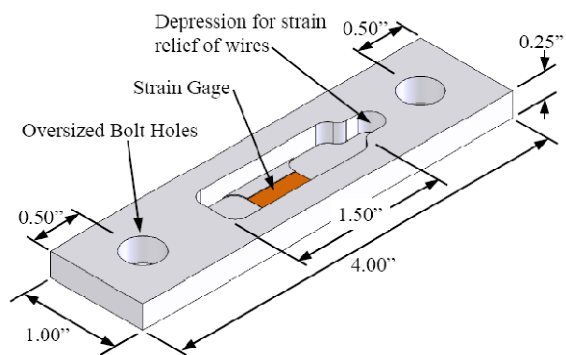
Figure 2.1: Configuration of the strain sensor.

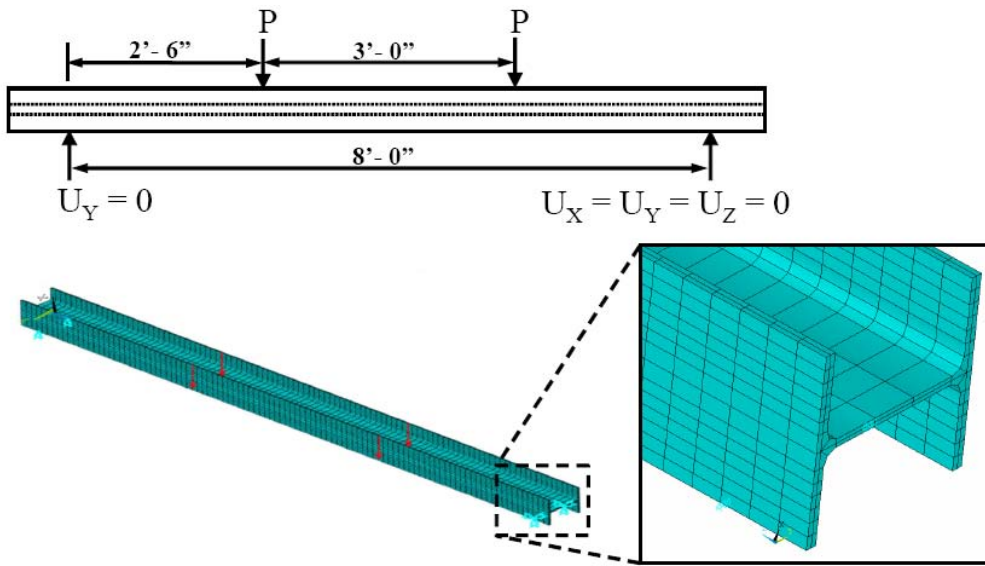
Figure 2.9: Boundary conditions of the 3D beam model.

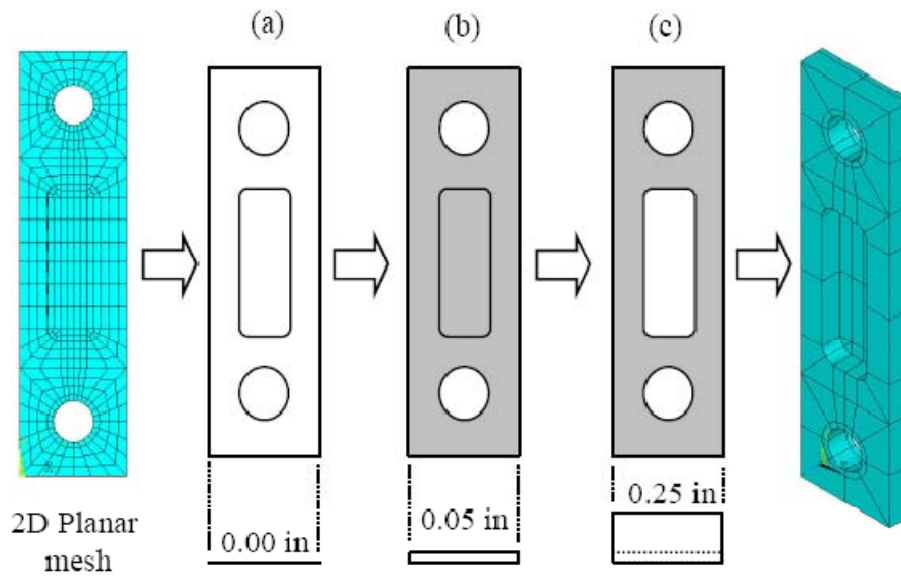
Figure 2.10: The extrusion process uses to build a 3D model of the sensor. It can be seen that from figure (a) the entire 2D planar mesh is extruded 0.05" in figure (b). The center depression is then created in figure (c) by extruding all areas around the depression.

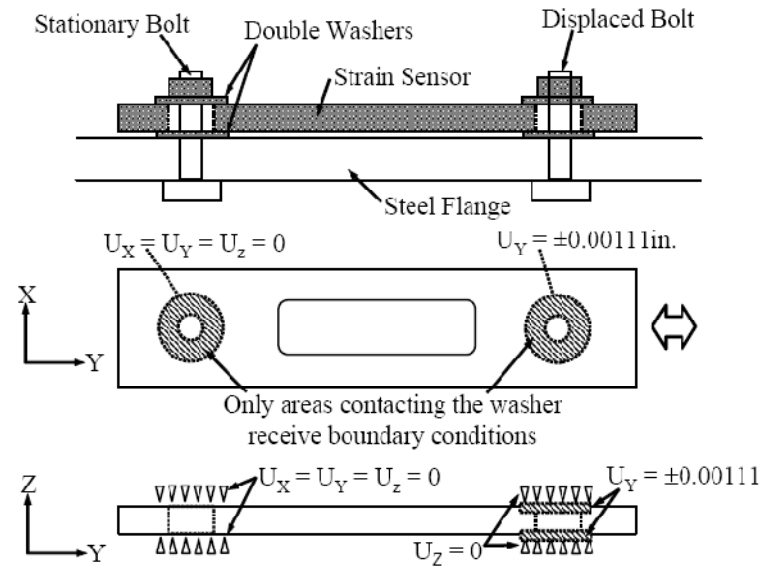
Figure 2.11 Boundary conditions for both compression and tensile cases of sensor model.

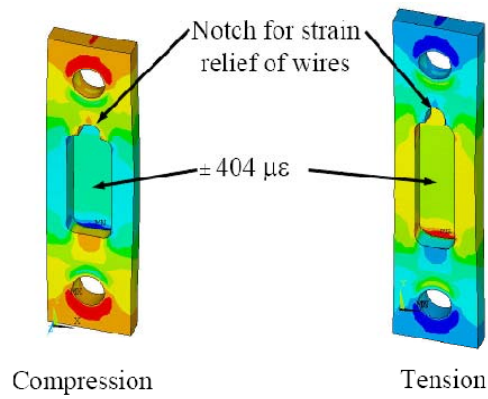
Figure 2.12: Longitudinal strain distribution for tension and compression cases for the sensor model.

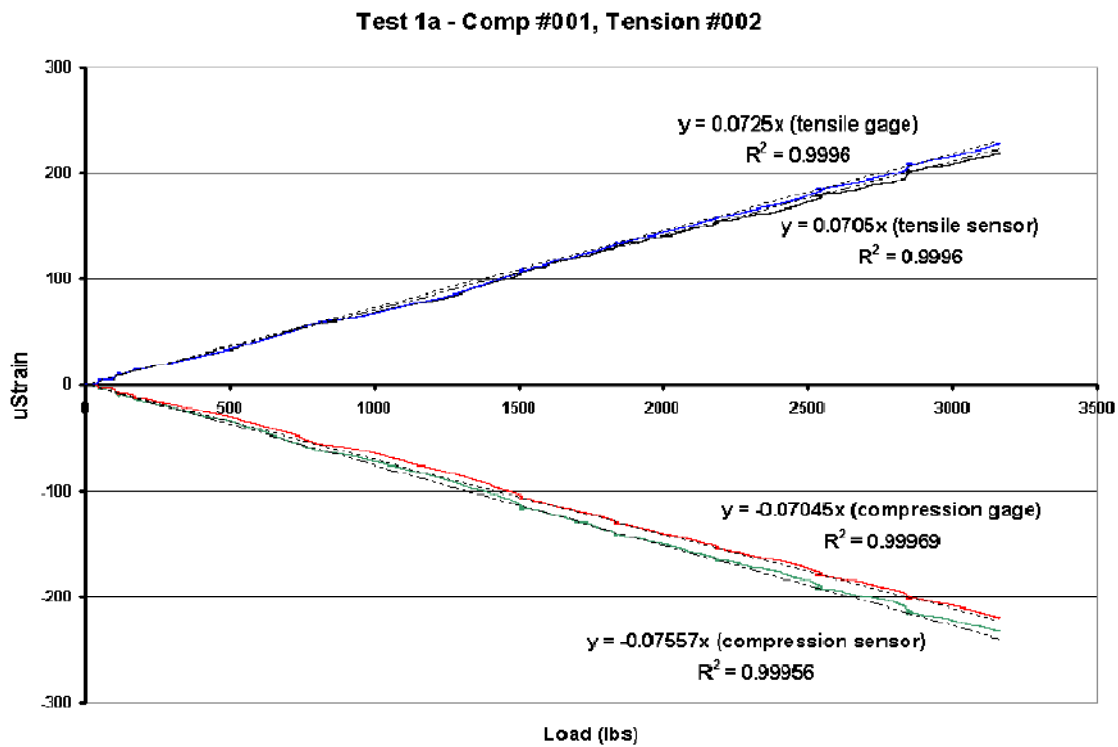
Figure 2.14: Typical response of strain gages and sensors under applied loading.

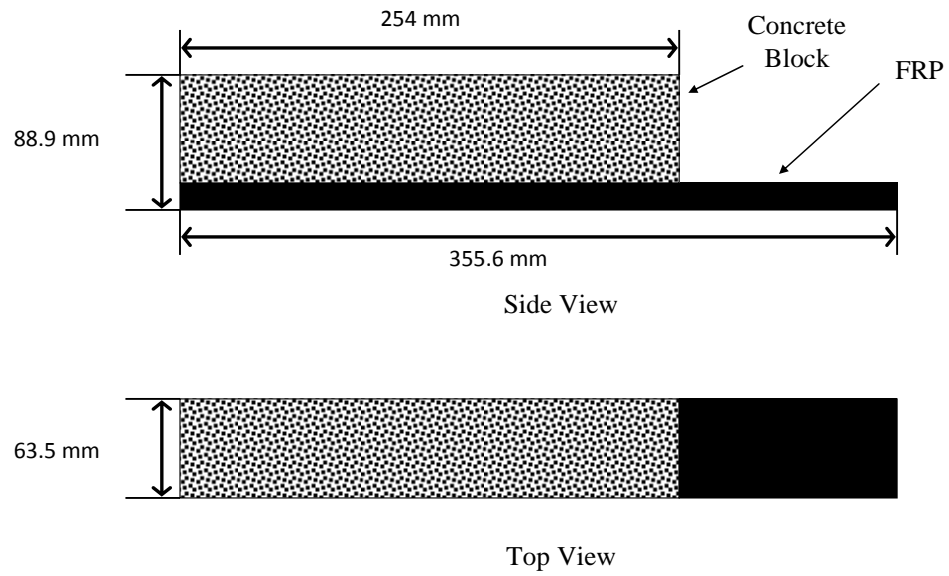
Figure 2.15: Specimen top and side views.

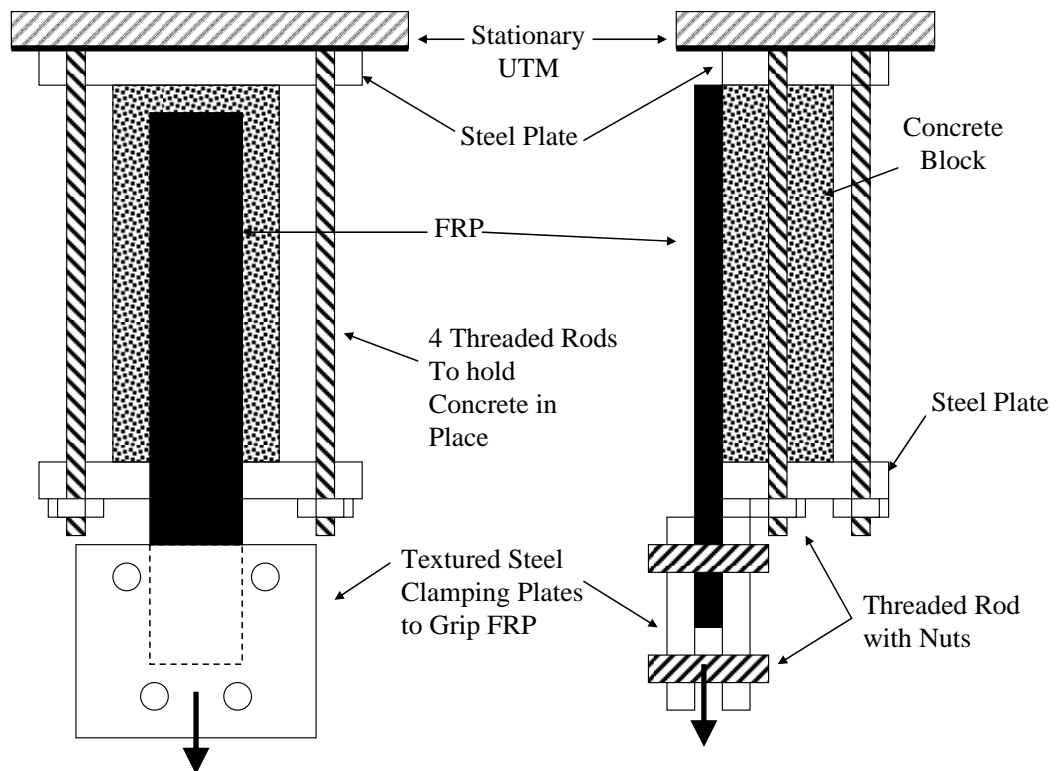
Figure 2.16: Single-shear testing setup.

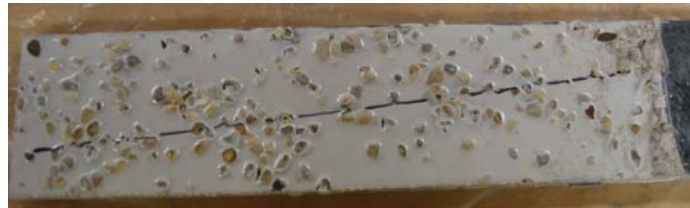
Figure 2.18 : Typical single-shear specimen failure: (a) failure surfaces; (b) typical 254 mm line drawn to check aggregate coverage (Berg 2004).

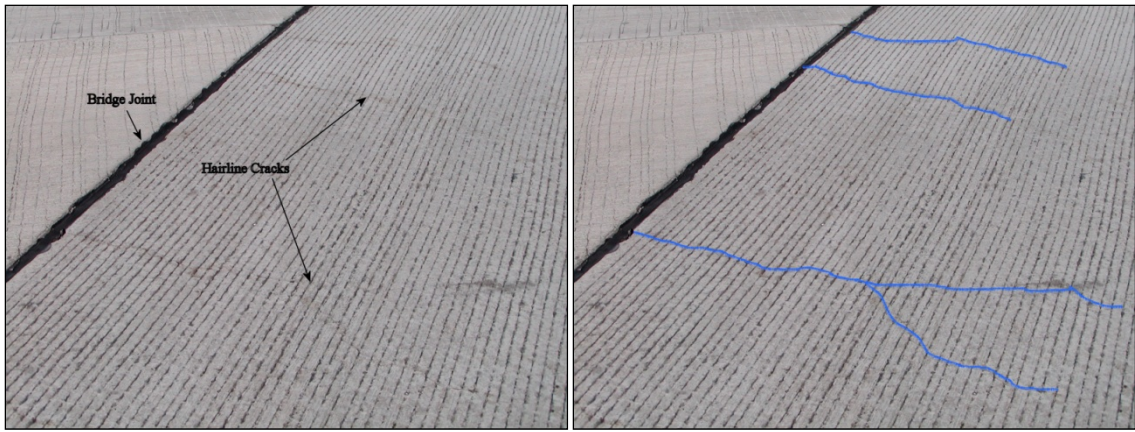
Figure 3.4 Hairline Cracks Near the Bridge/Abutment Joint

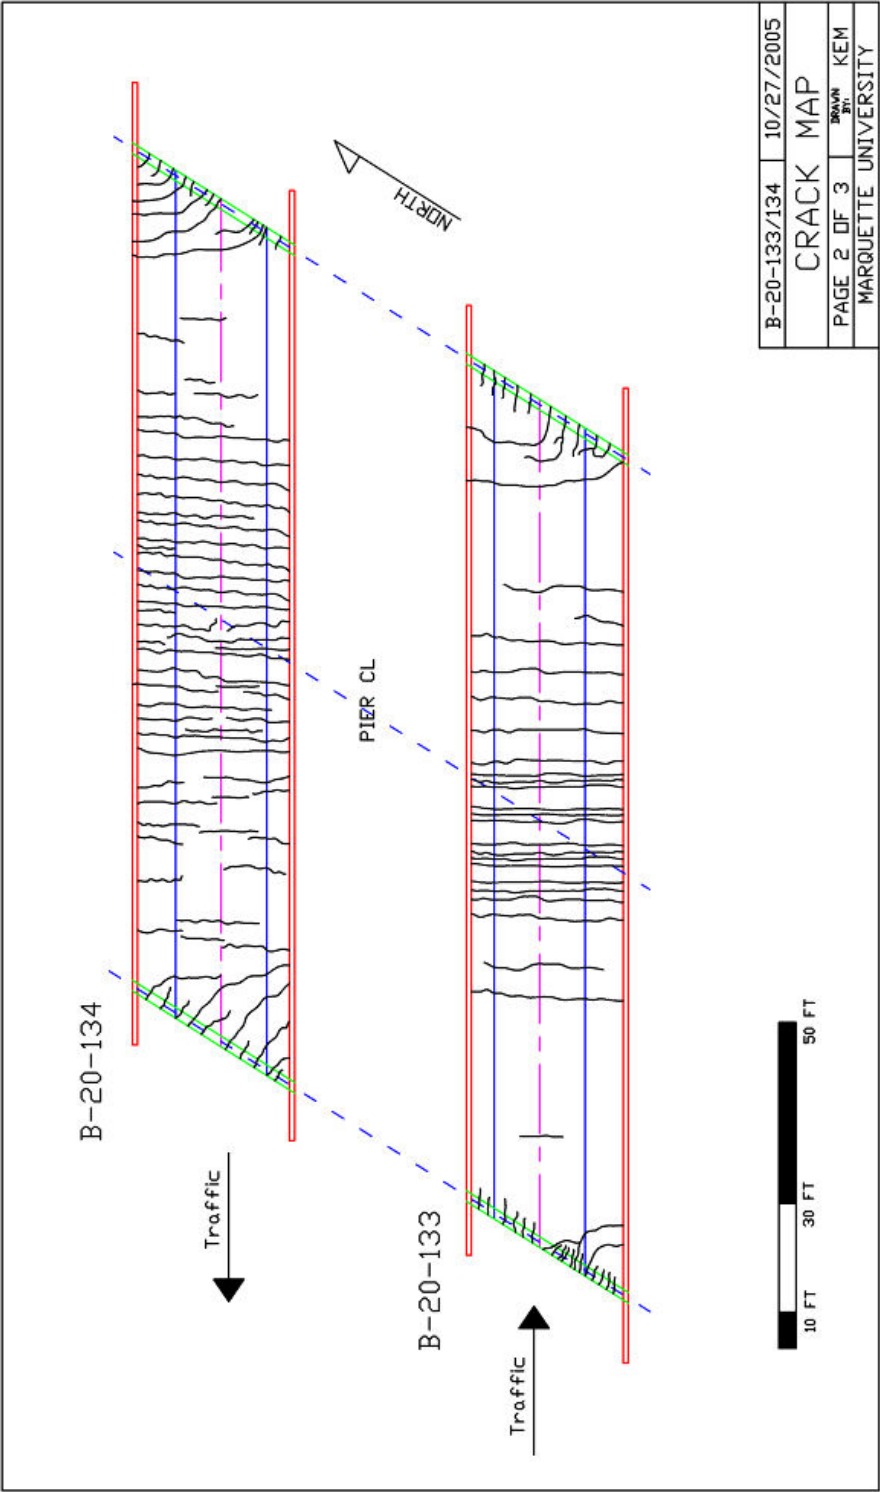
Figure 3.5 Crack Map of B-20-133/134

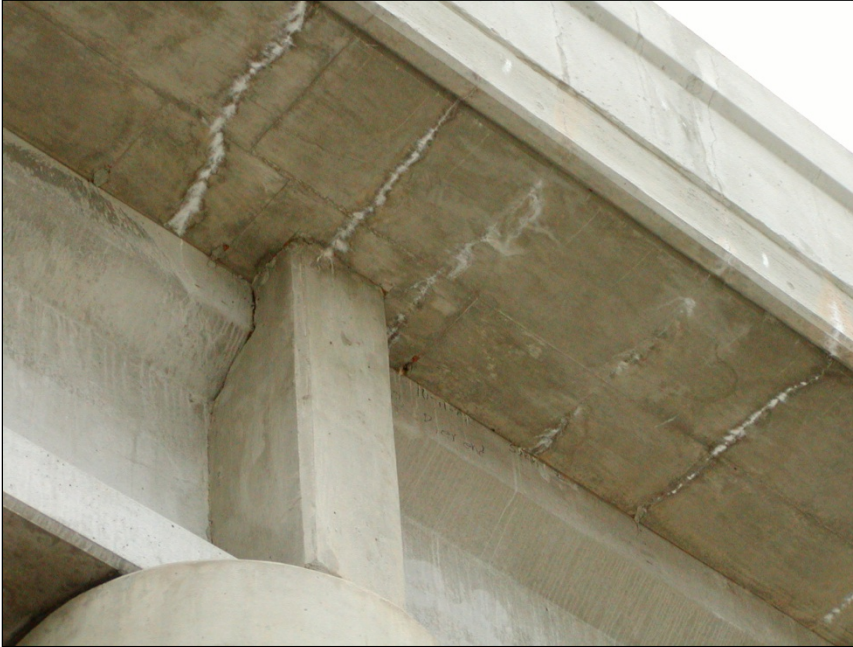
Figure 3.7 (3) Cracking with Efflorescence South Side of B-20-133 Above Central Pier

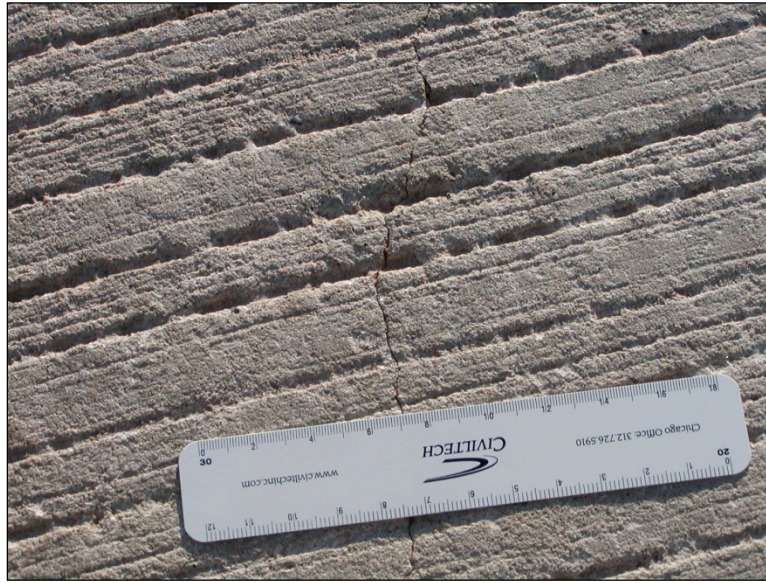
Figure 3.21 (6) Hairline Crack on Deck of B-20-149 with Scale

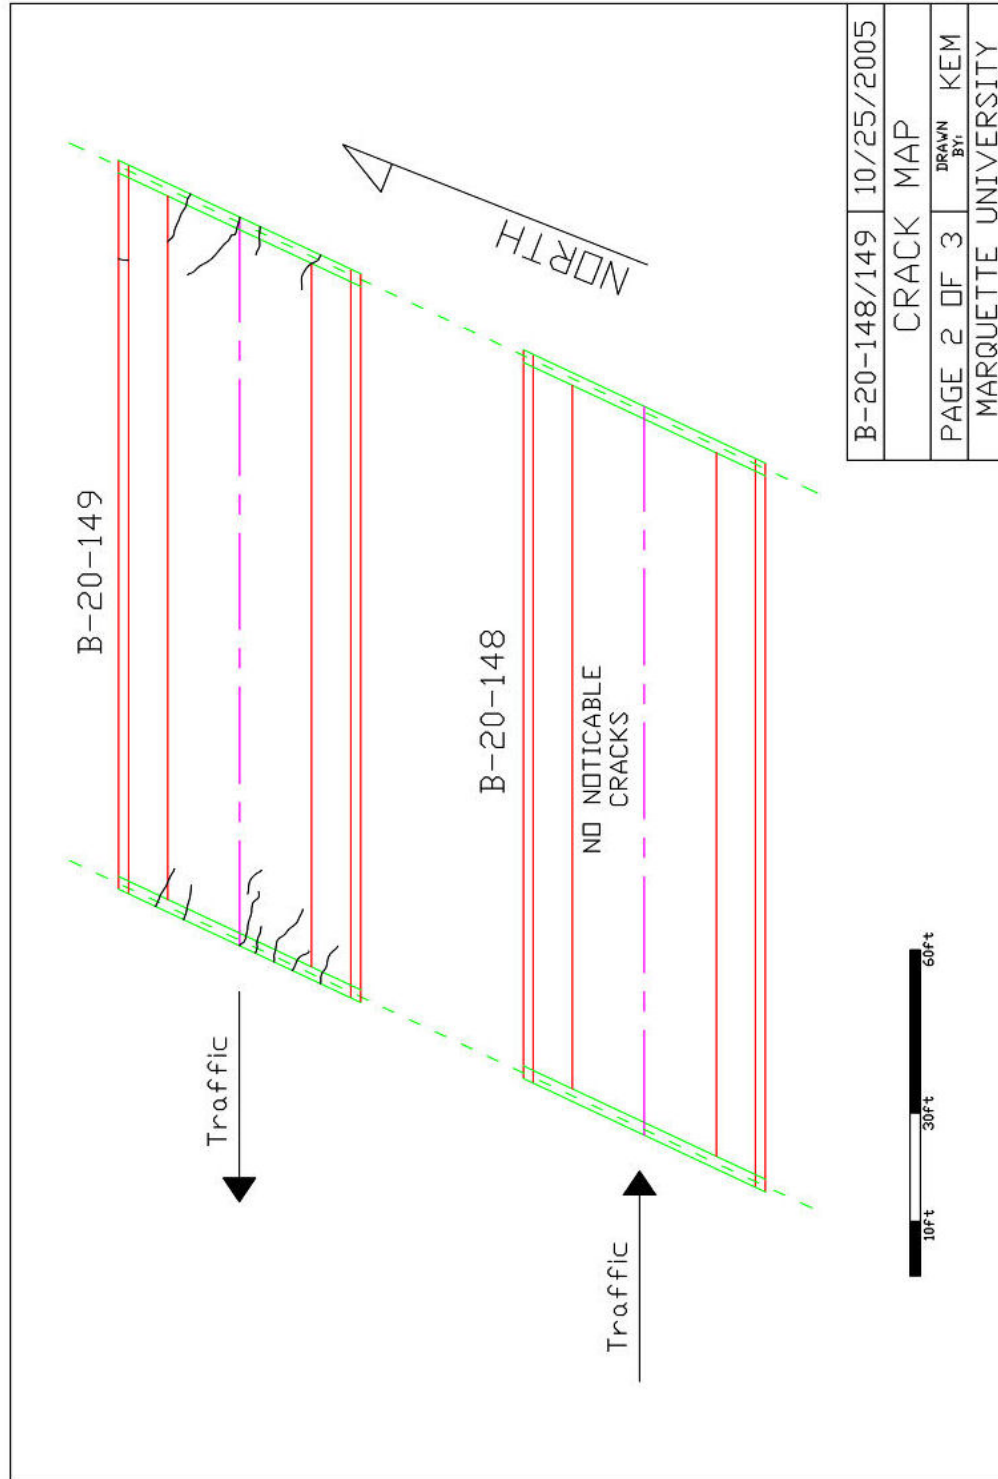
Figure 3.22 B-20-148/149 Initial Crack Map

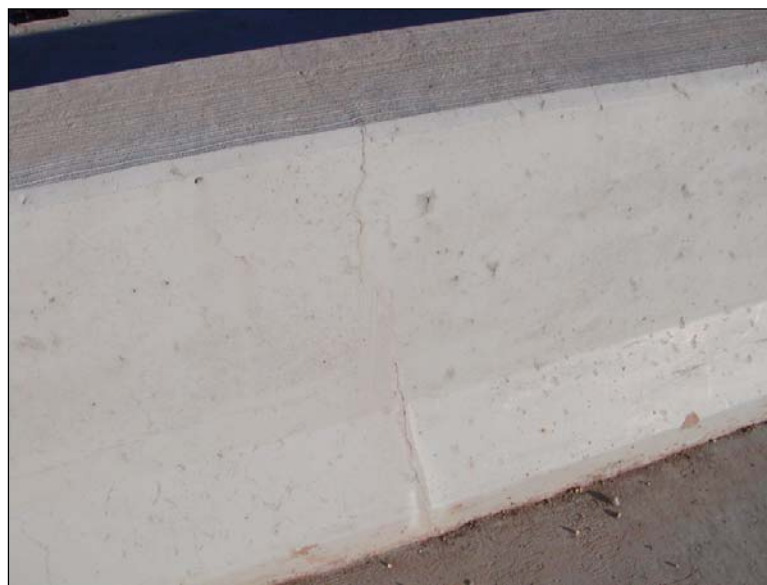
Figure 3.34 (5) Northern Parapet Crack on B-20-149

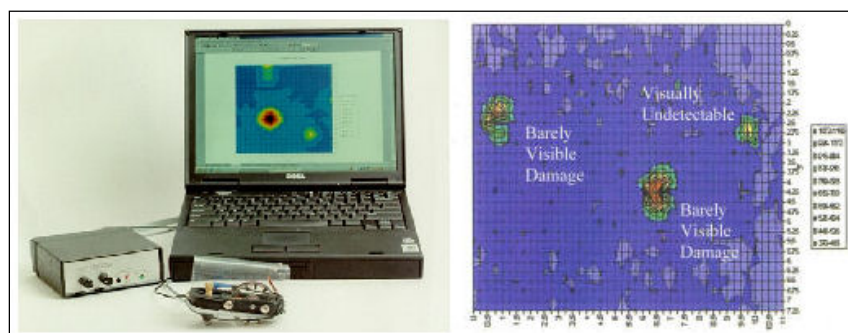
Figure 3.35 Computer Aided Tap Tester (CATT) and Testing a Heater Blanket of an American Airline MD80 (UCOMPO 2006)

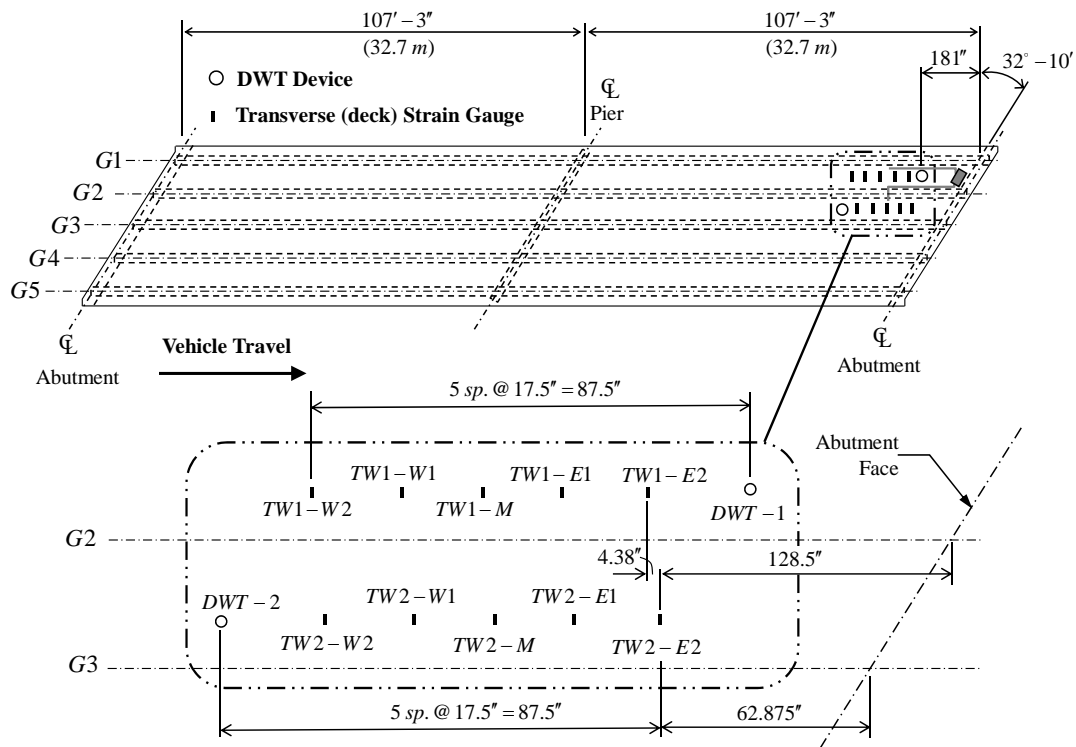
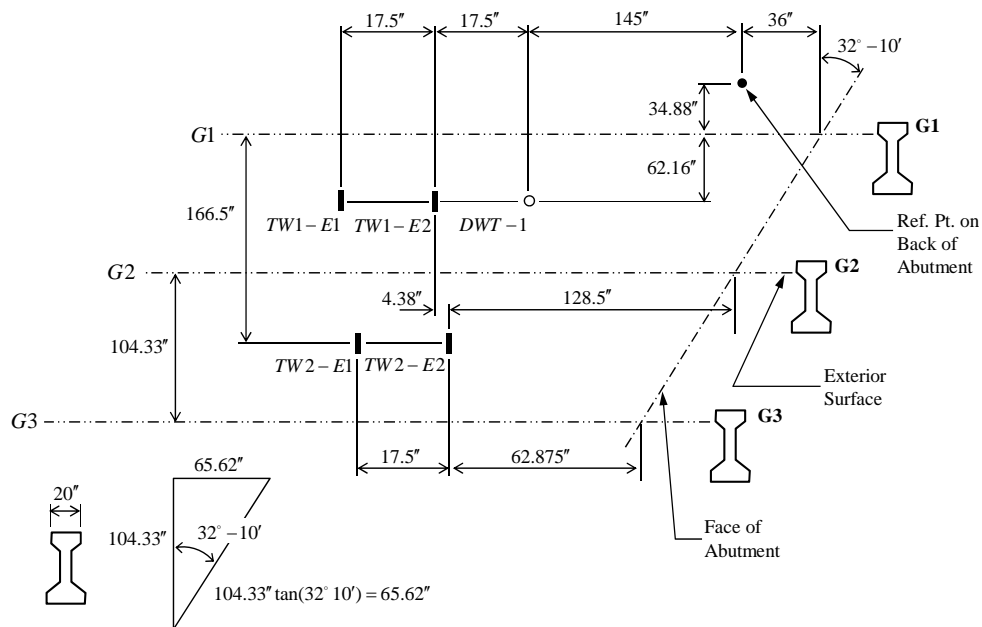
Figure 4.5 Instrumentation Layout and Instrumentation Plan Detail for B-20-133.

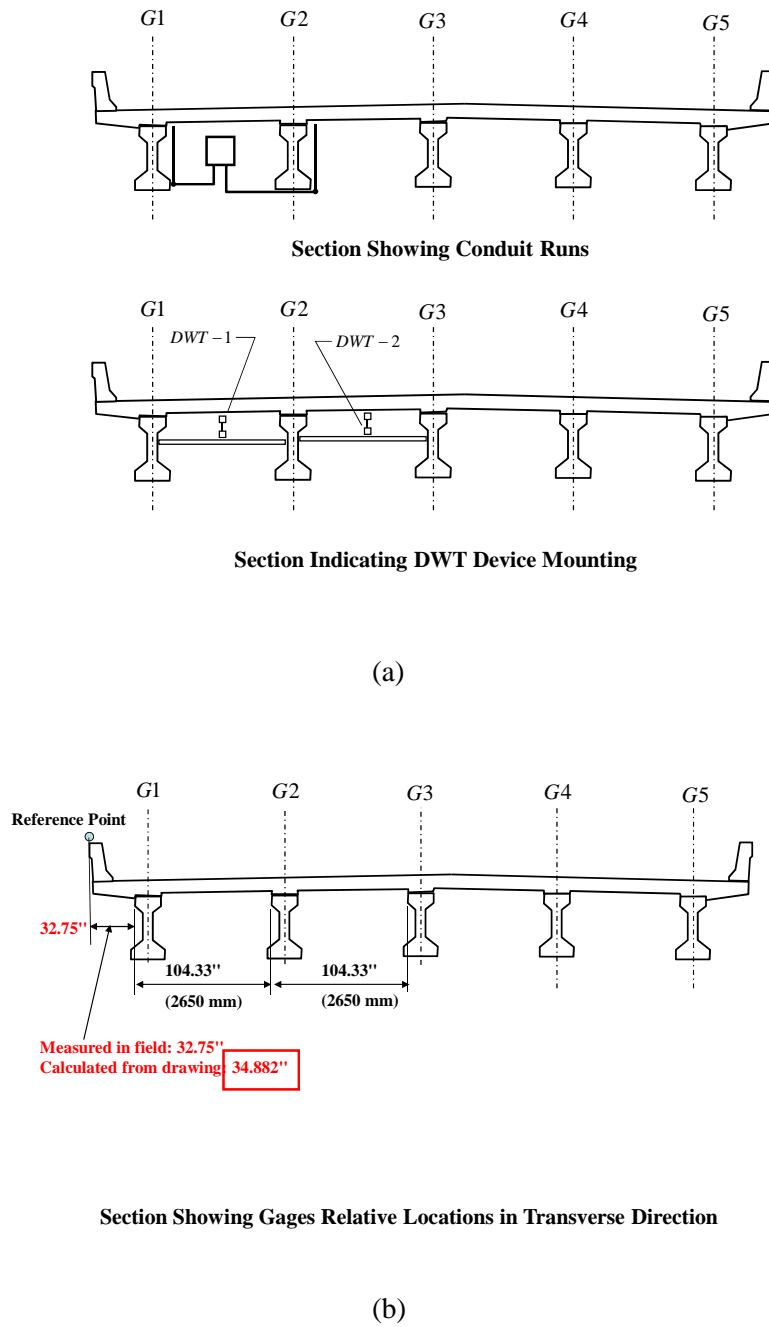
Figure 4.6 B-20-133 Cross-Sections Illustrating Instrument Layout: (a) Conduit Runs and Draw Wire Transducer Mounting; (b) Reference Point Location for Instrumentation.

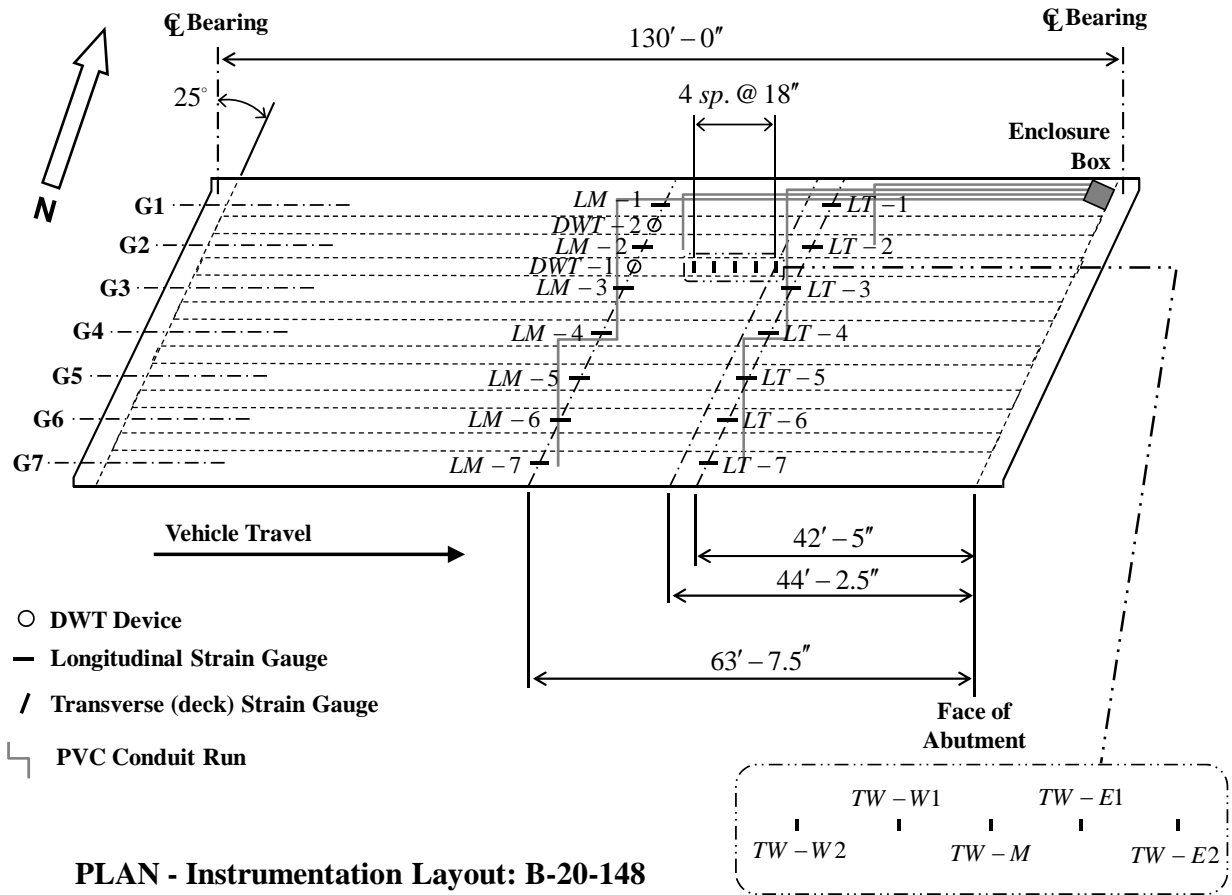
Figure 4.8 B-20-148 Instrumentation Plan with Sensor Locations, PVC Conduit Runs and Enclosure Box Location.

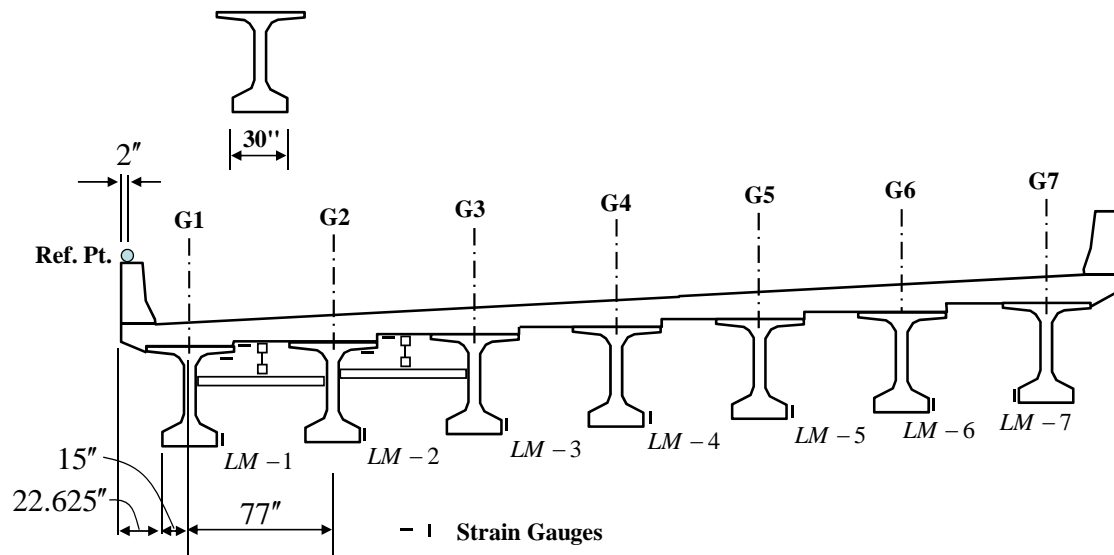
Figure 4.11 B-20-148 Strain Sensor Locations used to Measure Strain Distribution Over Height of Girders.

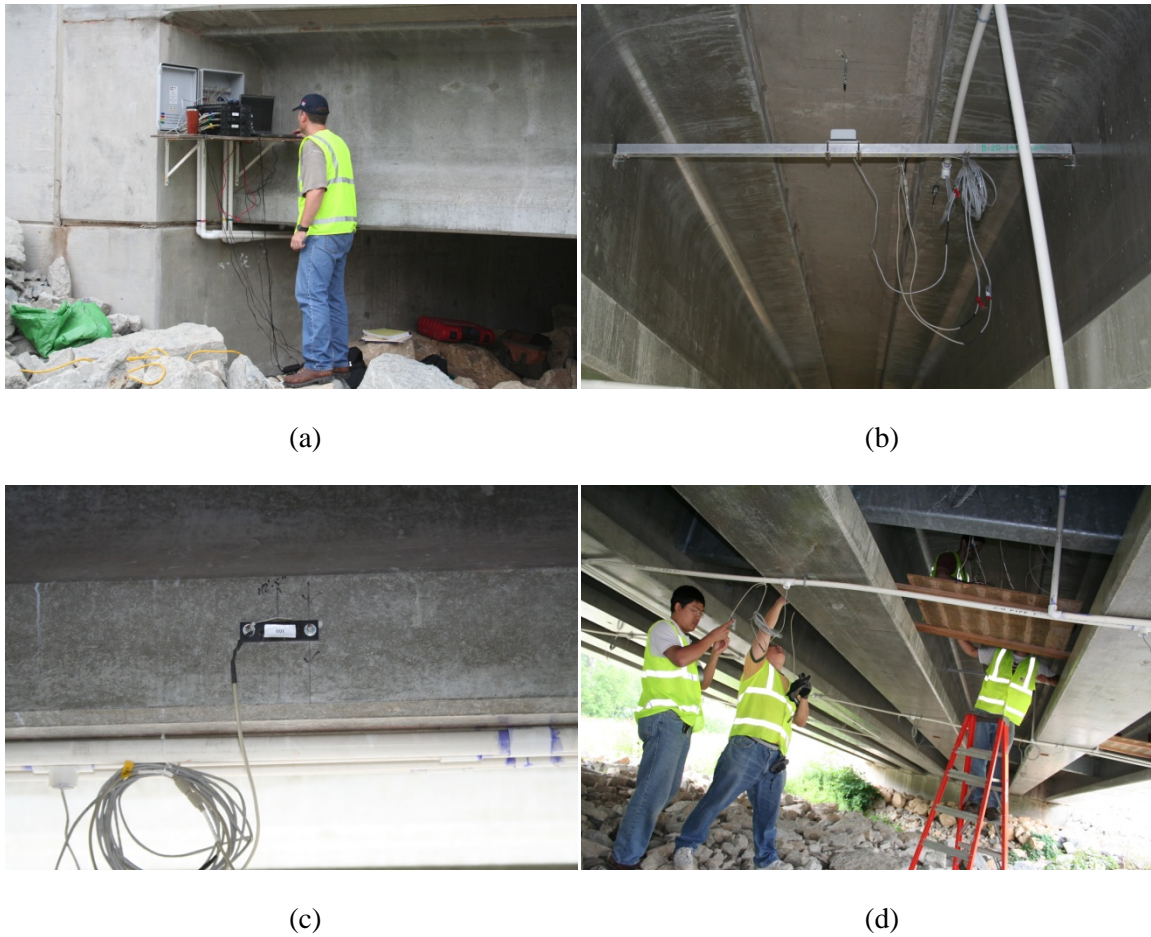
Figure 4.12 B-20-148 Data Acquisition System and Instrumentation: (a) Data Acquisition System and Enclosure; (b) Draw Wire Transducer Installation; (c) Strain Gauge Installation; (d) Sensor Wiring Runs and Sensor Installation.

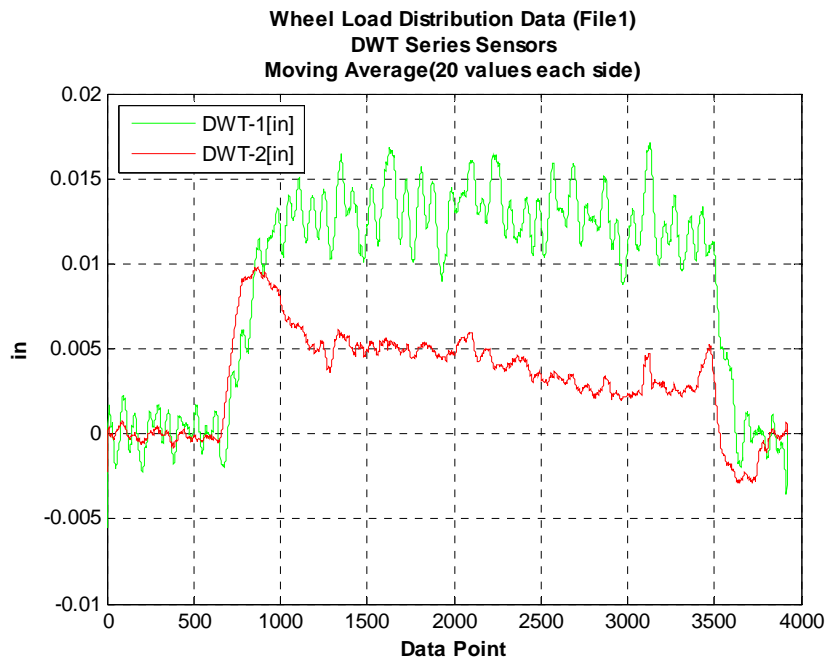
Figure 4.23 B-20-133 Bridge Deck Displacements Measured for Truck Travel Path 1 (Figure 4.16) during Load Testing: (a) July 2007; (b) July 2009.

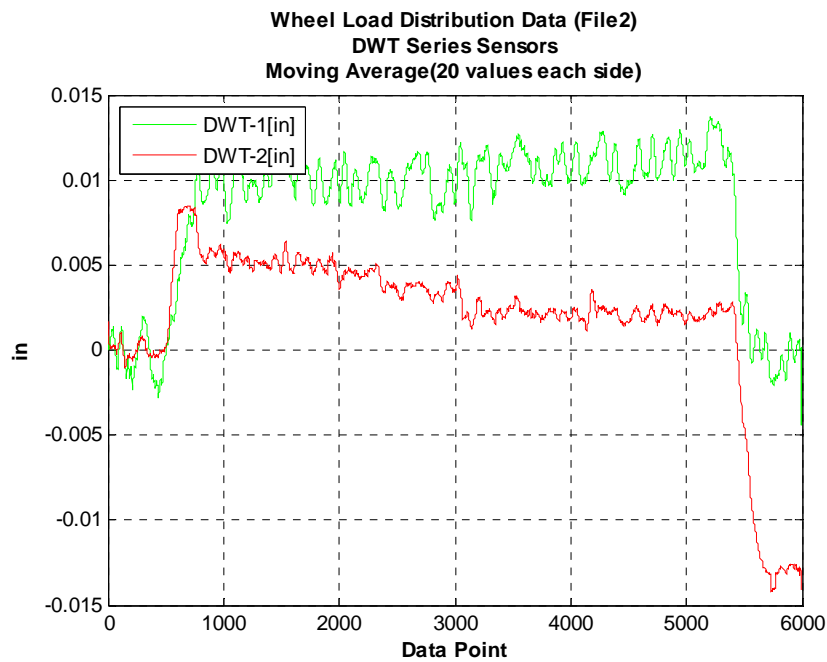
Figure 4.24 B-20-133 Bridge Deck Displacements Measured for Truck Travel Path 2 (Figure 4.17) during Load Testing: (a) July 2007; (b) July 2009.

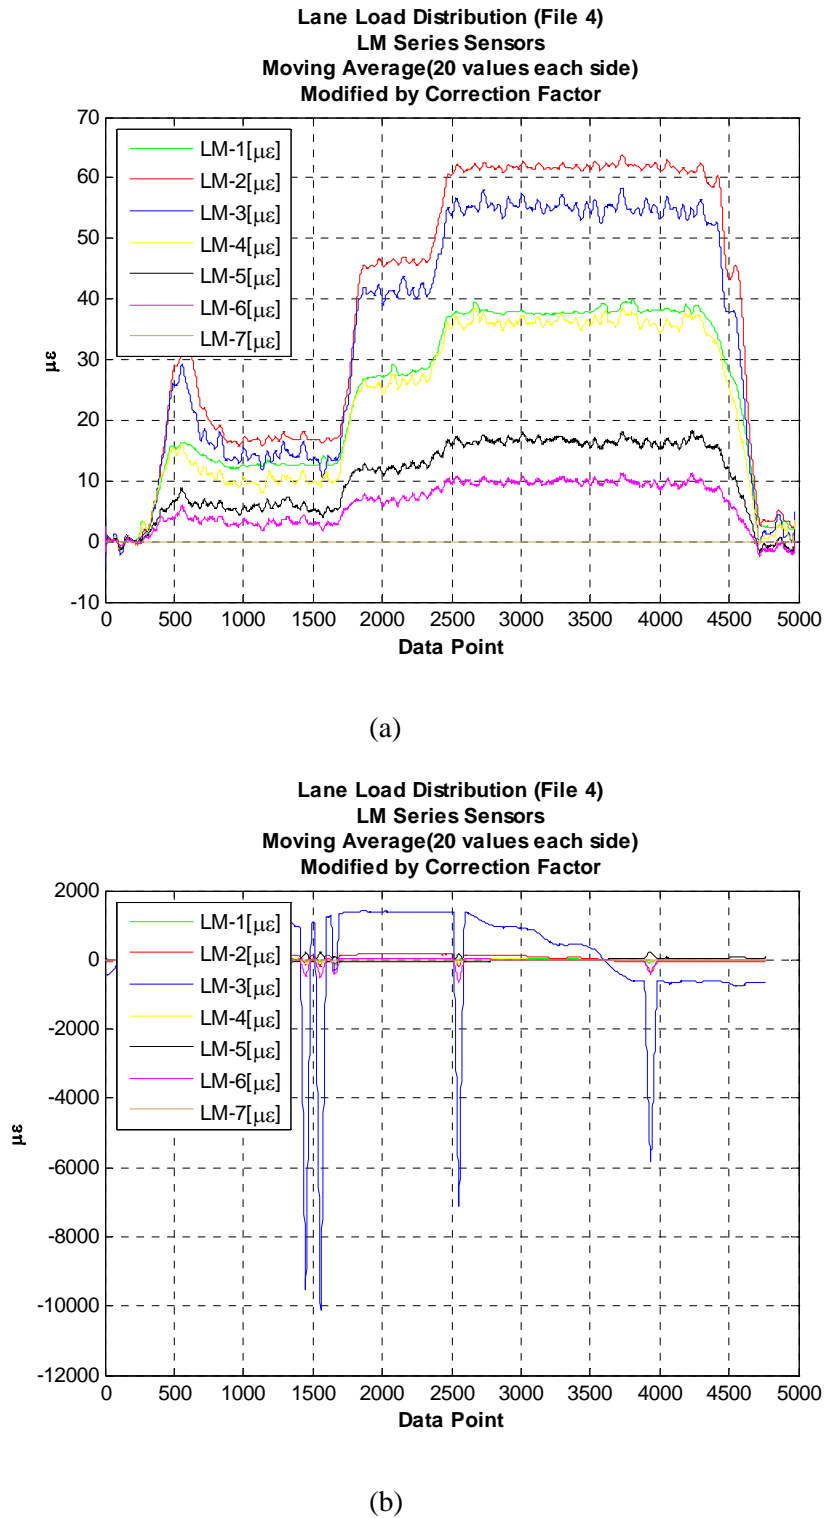
Figure 4.32 B-20-148 Lane Load Distribution Strains at Mid-Span of Girders for Truck Position 4

(Figure 4.21) Measured During Load Tests: (a) July 2007; (b) July 2009.

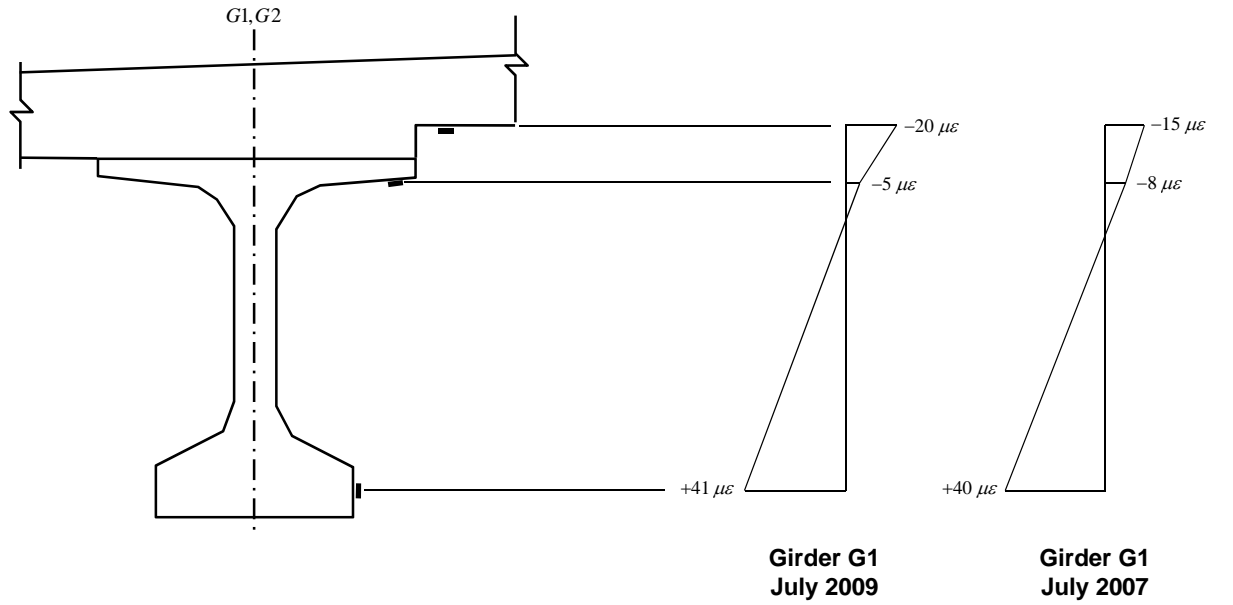
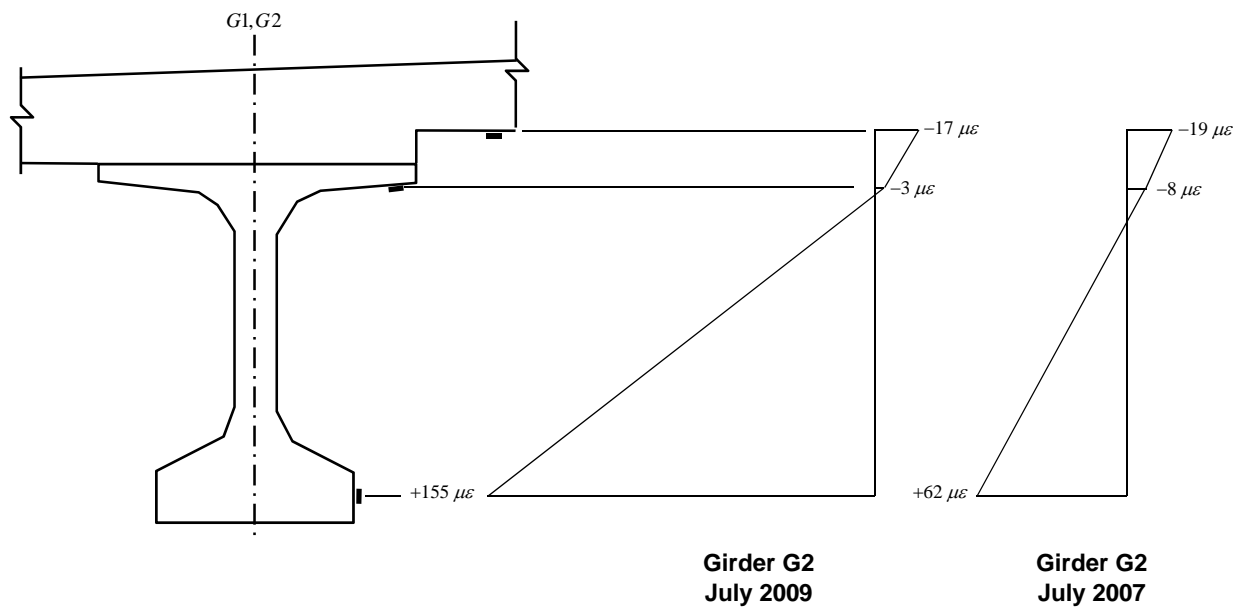
Figure 4.36 B-20-148 Strains over Girder Height for Girders G1 and G2 for Truck Position 4 (Figure 4.21) Measured During Load Tests: (a) Girder G1; (b) Girder G2.

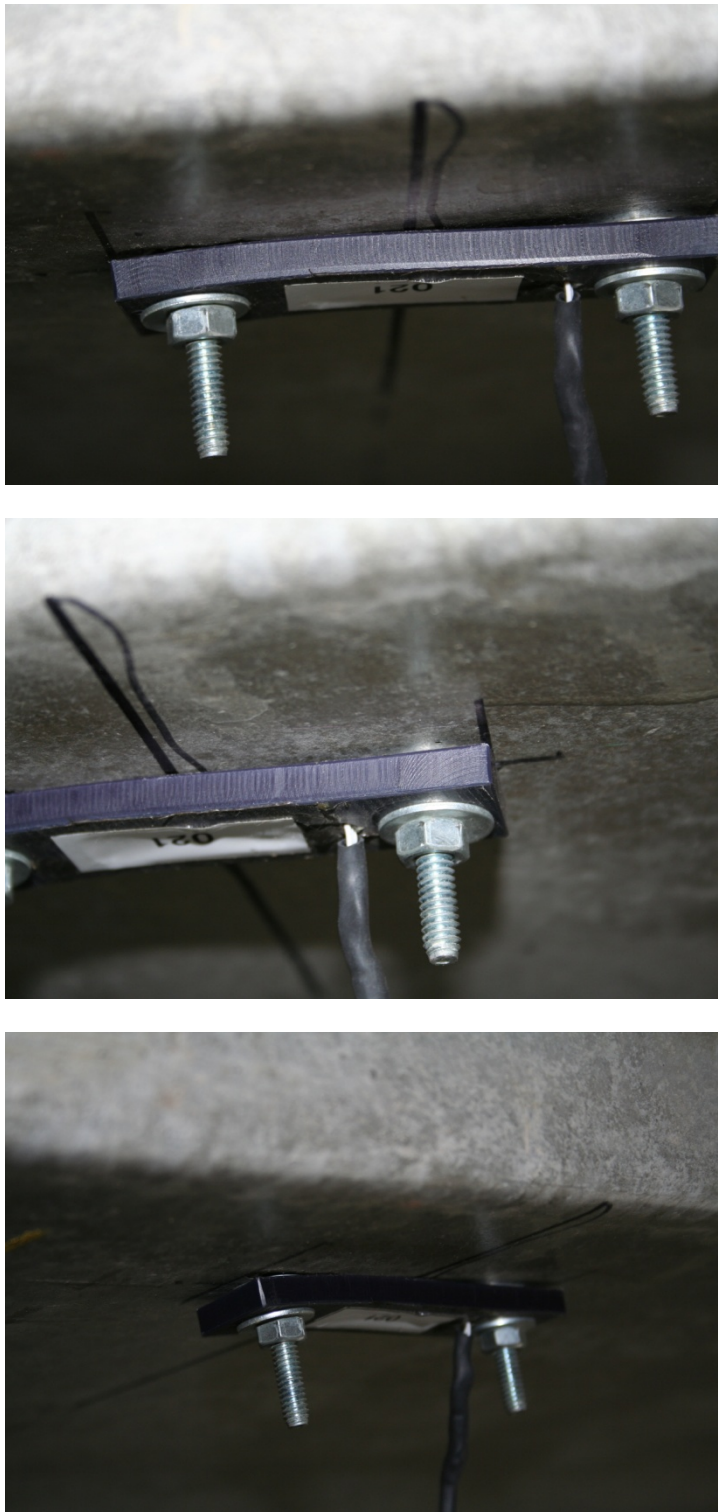
Figure 4.37 Strain Sensor Installation Error with Potential to Cause Error in Strain Readings.

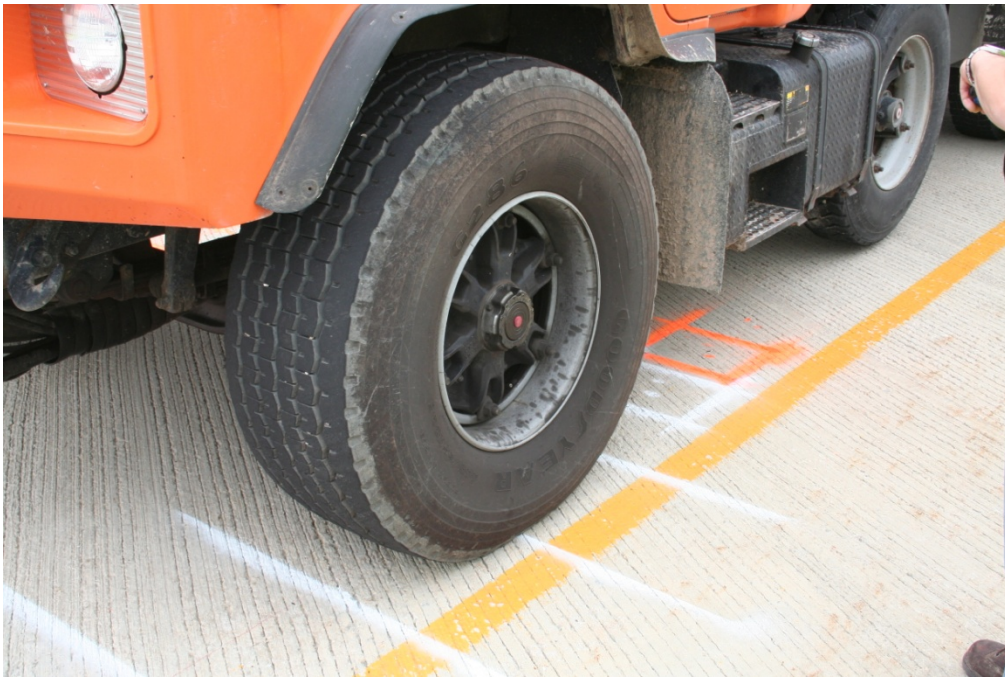
Figure 4.38 Method for Truck Wheel Positioning on Bridge Deck.

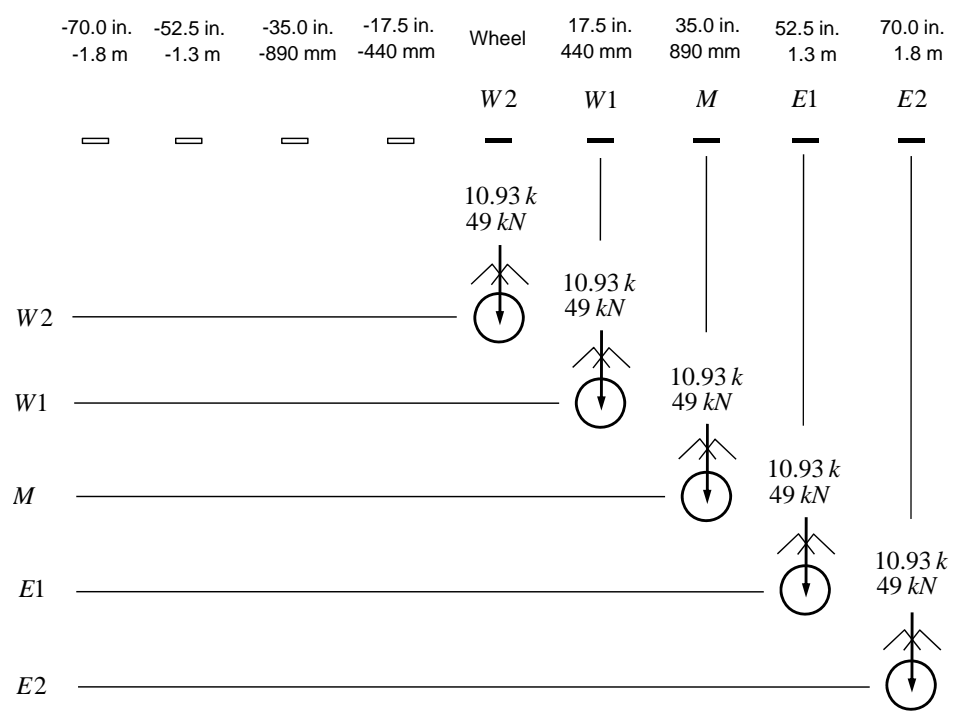
Figure 4.39 Front Wheel Position Relative to Mounted and Symmetrically Extrapolated Strain Sensors.

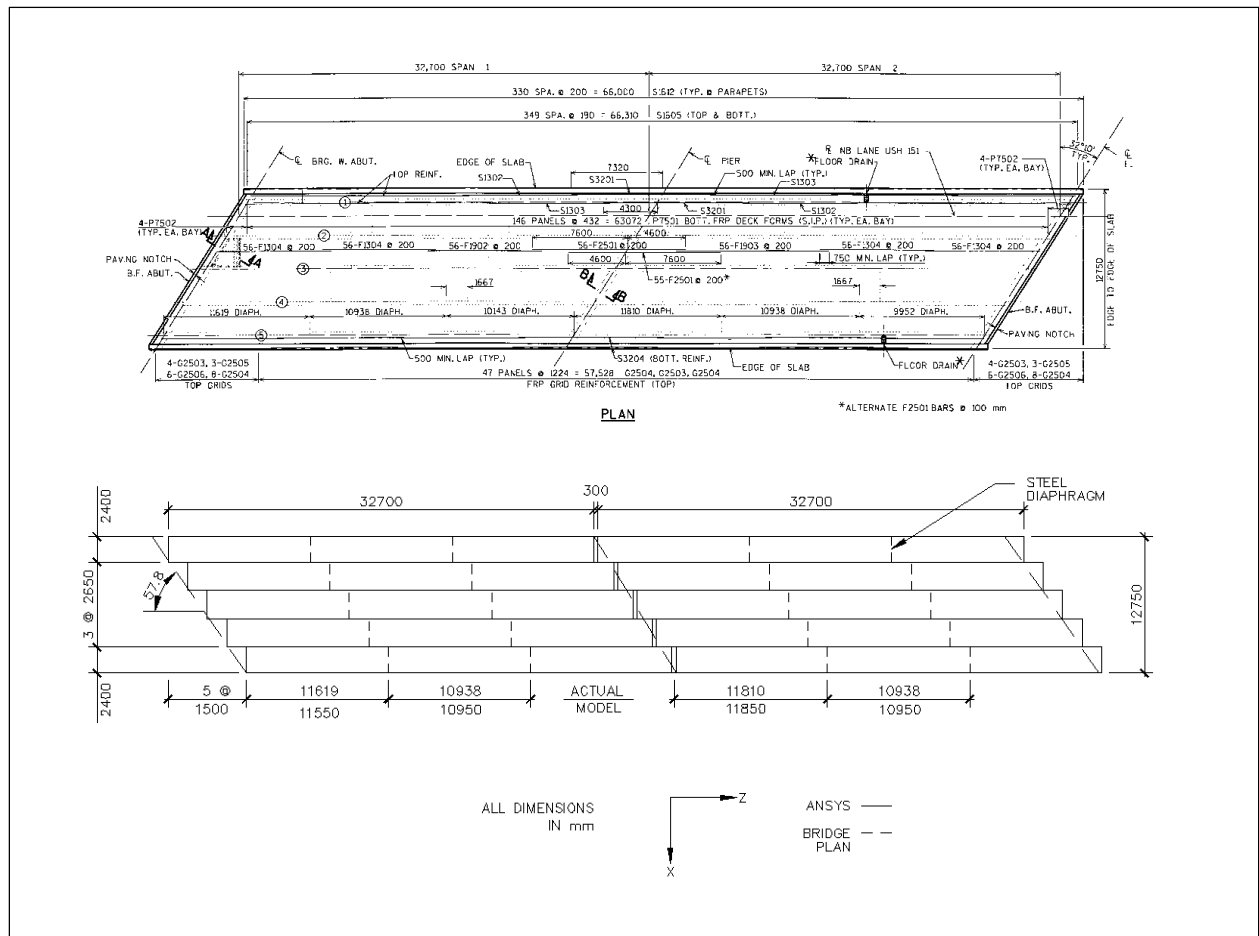
Figure 5.2 Bridge B-20-134 Plan and Plan View of Deck Finite Element Modeling (Komp 2009).
